## Phase I Environmental Site Assessment Report

Davies Property  
Approximate 8-Acres  
4501 Otay Valley Road  
Chula Vista, California

Converse Project No. 02-41-346-01  
April 15, 2003

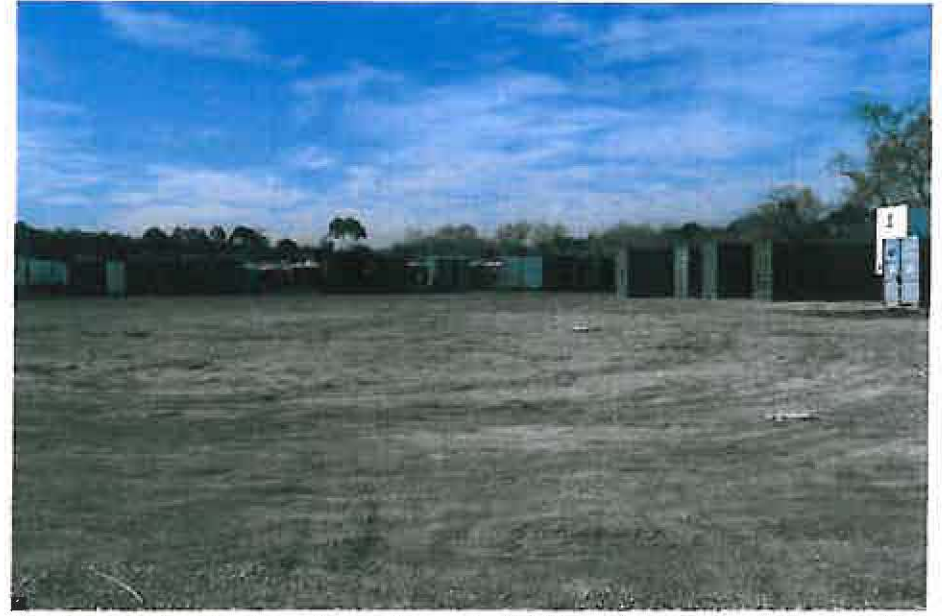
**2. Approximate location of graded fill and storage bins on the northeastern portion of the Property.**

| Item or Condition | Observed<br>Evidence | No<br>Evidence<br>Observed | Comments |
|---|---|---|---|
| | | | Approximately 50 portable storage bins were observed on the eastern portion of the Property. The interiors of ten (10) of the bins were accessed, and observed to be empty. Staining was observed to the ground below the bins. |

| Item or Condition | Observed Evidence | No Evidence Observed | Comments |
|---|---|---|---|
| Stained Soil or Pavement: | <input checked="" type="checkbox"/> | <input type="checkbox"/> | Staining was observed on the soil in the vicinity of several storage bins on the eastern portion of the Property. |

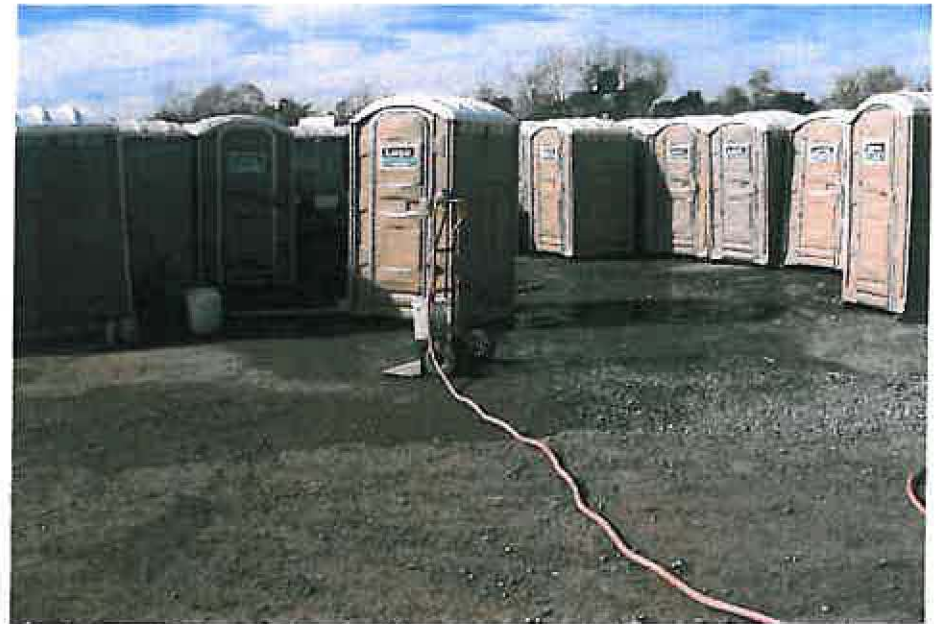
**4. Porta-potties and standing pool located on central portion of the Property.**

| Item or Condition | Observed Evidence | No Evidence Observed | Comments |
|---|---|---|---|
| Pits, Ponds, or Lagoons: | <input checked="" type="checkbox"/> | <input type="checkbox"/> | Several pools of water mixed with a cleaning solution (approximately 10-foot by 25-foot and 10-foot by 10-foot) were observed on the north-central portion of the Property in the vicinity of the porta potties. An odor was detected. |
